**A RESERVE STUDY UPDATE FOR**

**Summer Winds  
Condominiums, Inc.  
Indian Beach, North Carolina  
File #22920-00929**

**FOR PERIOD: October 1, 2015 – September 30, 2016**

**PREPARED BY  
GAB ROBINS, A DIVISION OF CUNNINGHAM LINDSEY  
3300 W. LAKE MARY BLVD.  
SUITE 350  
LAKE MARY, FLORIDA 32746-3405  
(800) 248-3376 ext. 257  
(407) 805-0086 ext. 257**

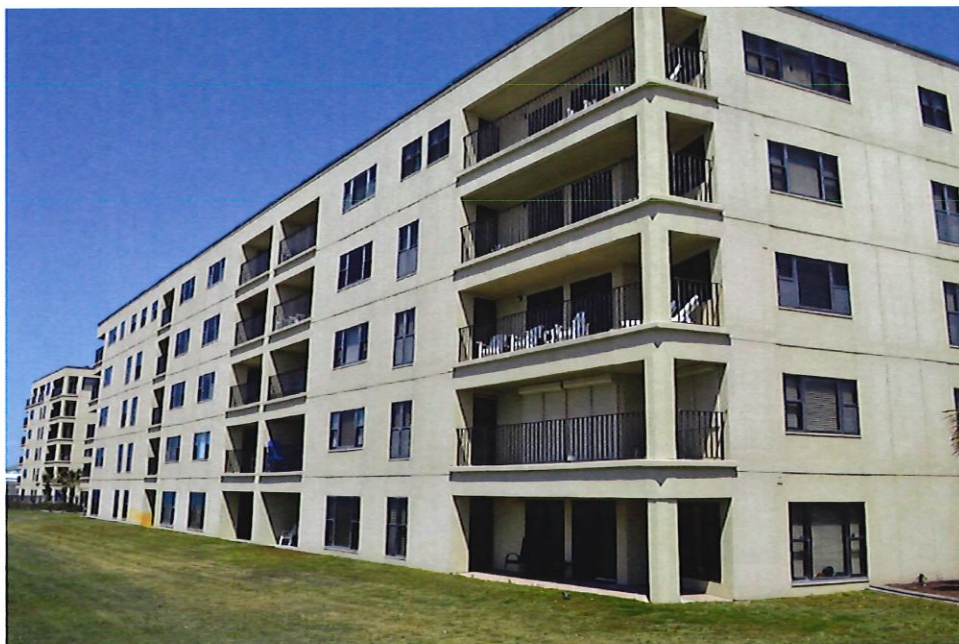
At some point in the foreseeable future, the association should expect to incur costs for replacement of the balcony railings, which were assumed to be limited common elements and therefore the financial responsibility of the association. Replacement is sometimes completed in conjunction with major concrete restoration; we have observed life cycles for railings replacement after less than 25 years, while some properties of 40+ years in age have yet to complete replacement. The 2015 exterior restoration project will reportedly not include the balcony railings; this fund is designed to provide monies for as needed repairs to and eventual replacement of these railings over a 40 year life cycle. The current per linear foot cost estimate includes removal and disposal of the existing railings, typical minor concrete repairs, and installation of railings of similar height/quality.

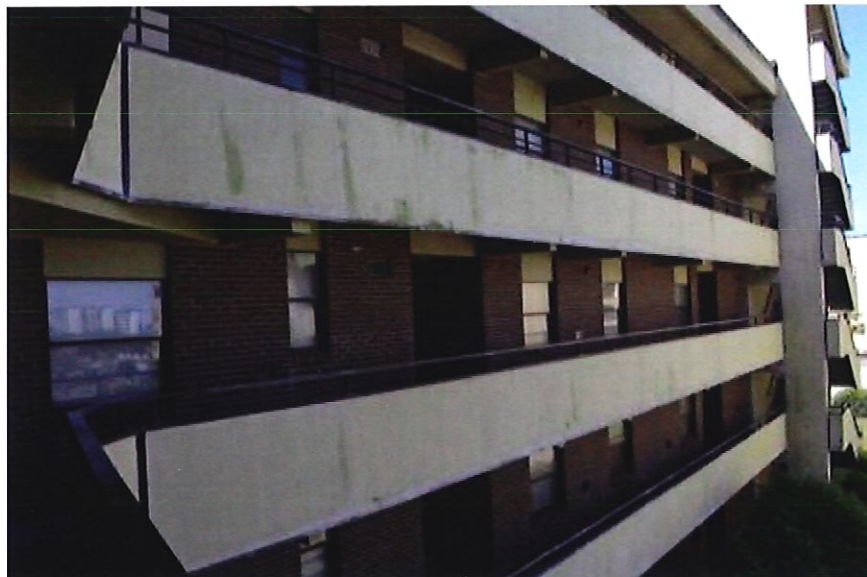
The railings/panels at the exterior walkways were observed to be in only fair condition, and the association expects to replace as a portion of a 2015 exterior restoration/waterproofing project. We have observed life cycles for railings replacement after less than 25 years, while some properties of 40+ years in age have yet to complete replacement. This fund is designed to provide monies for as needed repairs to the walkway railings/panels over a 30 year life cycle, based on an assumed summer/fall 2015 installation date. The current per linear foot cost estimate includes removal and disposal of the existing railings, typical minor concrete repairs, and installation of railings of similar height/quality.

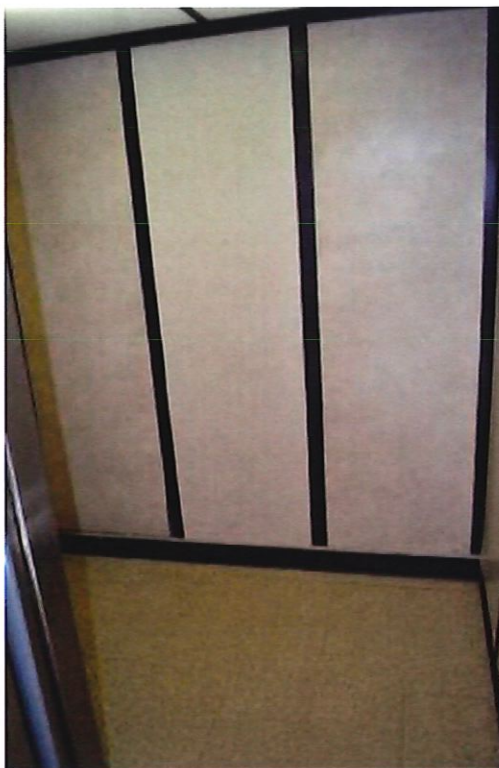
Major cosmetic refurbishment of passenger elevator cabs (flooring, wall finishes, ceilings/lighting, etc.) has been observed on life cycles in the 15-20 year range in properties of similar overall quality, with the most typical falling on the higher end of the range. The date of completion of the most recent project was not confirmed; this report assumes that cosmetic renovations will be completed concurrently with mechanical modernization, and a 2016 expense date scheduled accordingly.

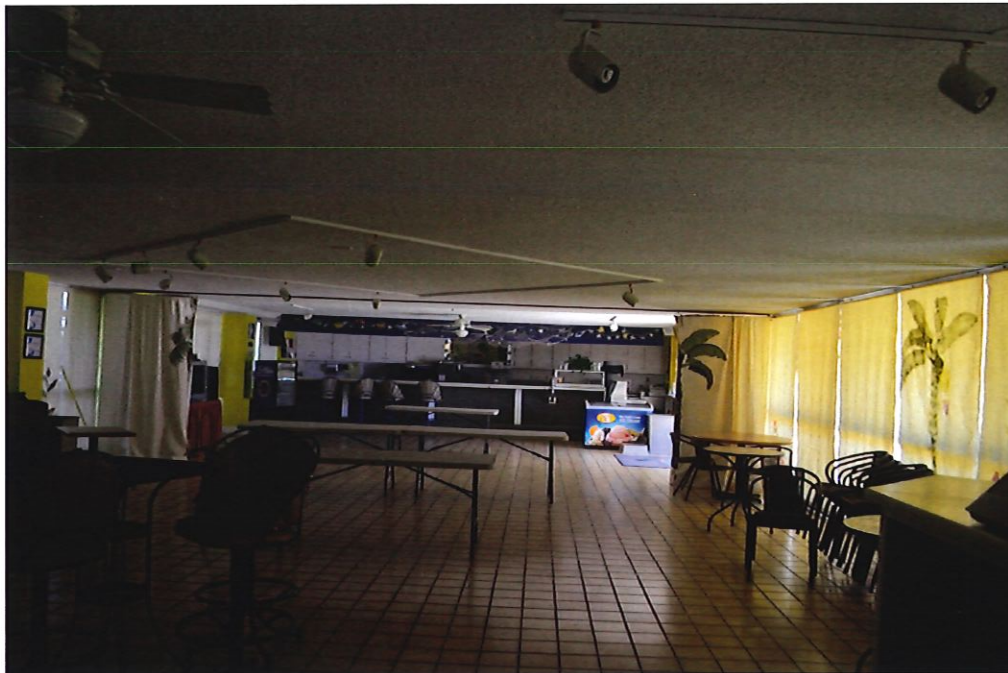
To insure a modern cosmetic appeal, the association should expect to complete major common area furnishings projects on a periodic and regular basis. While minor additions/replacements/upgrades can be expected from time to time, a life cycle in the 10 to low 10 year range is the market norm we have observed. This fund is designed to provide monies for as needed furnishings and finishes in Ginger's Cafe, including wall and ceiling finishes, tables, chairs, bar stools, draperies/window treatments, wall art, etc. over a recurring 12 year life cycle. The next major expense was forecast in summer 2017.

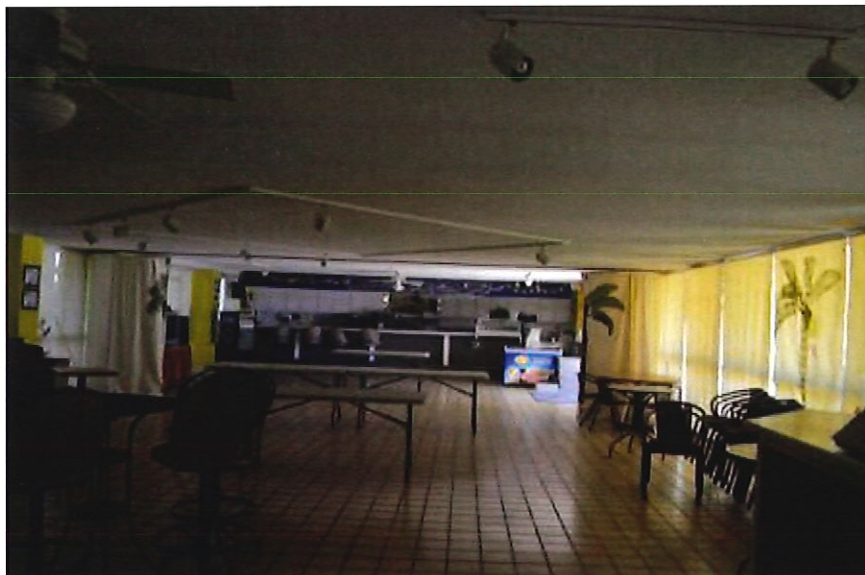
At some point in the foreseeable future, the association should expect to incur costs for replacement of the common area tile flooring. Because replacement is typically completed due to cosmetic dissatisfaction rather than physical wear out/failure of the flooring itself, life cycles can vary from property to property; we have observed life cycles of less than 10 years, to over 30 years, for replacement of tile flooring. The tile flooring in Ginger's Cafe is reportedly original, suggesting an actual age of +/- 32 years. As such, the association should expect to incur replacement costs in the near future. As there were no reported plans to complete any cosmetic renovations in the near future, a summer 2016 expense date was forecast. The current cost estimate includes removal and disposal of the existing tile flooring and installation with like quality.

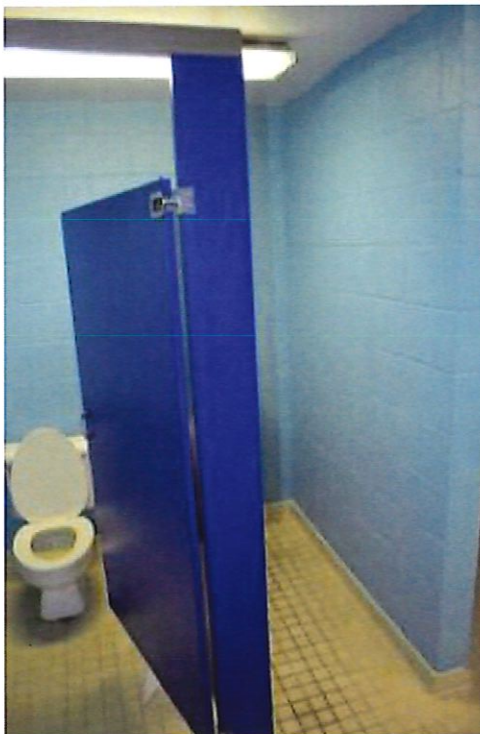
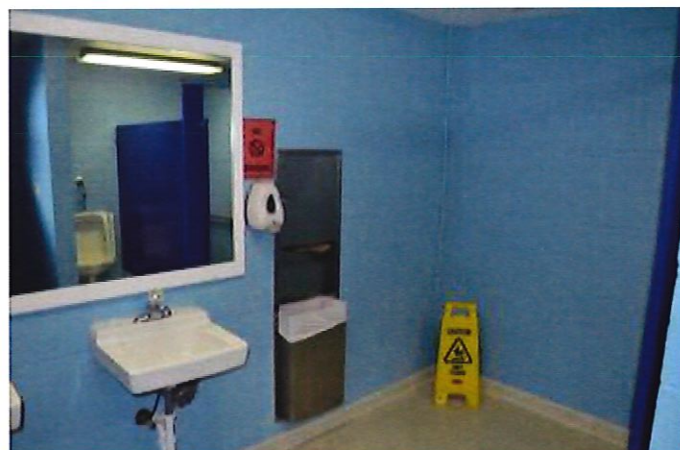
This fund refers to major third party restoration/renovation of the pool/beach restrooms interiors, including tile flooring, dividers/doors, plumbing and electrical fixtures, mirrors, etc. These interiors appear to be largely original to the property, and as such, renovation should be completed in the near future to insure a modern cosmetic appeal. As there were no reported plans to complete any common area renovations in 2015, a summer 2016 expense date was forecast.

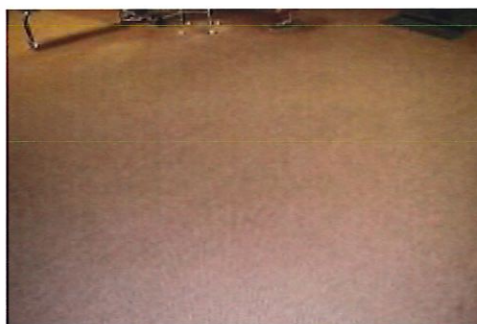
Life cycles of 5-6 years, to 15+ years, have been observed for replacement of carpeting in primary common area interiors (hallways, social rooms, exercise rooms, administrative offices, etc.); the useful life depends on the quality of carpeting, level of ongoing maintenance, and association cosmetic tastes. Based on the condition of this carpeting, and given that no cosmetic renovations are expected in 2015, a summer 2016 expense date was forecast. The current cost estimate includes removal and disposal of the existing carpeting and installation of like quality. The floor area estimate includes a typical market waste allowance.

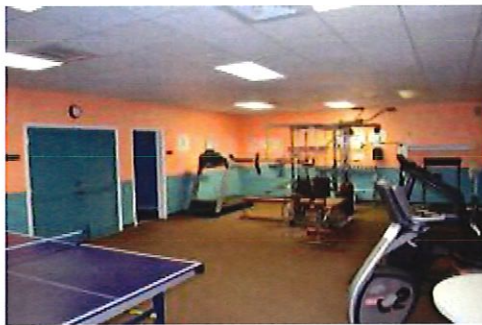
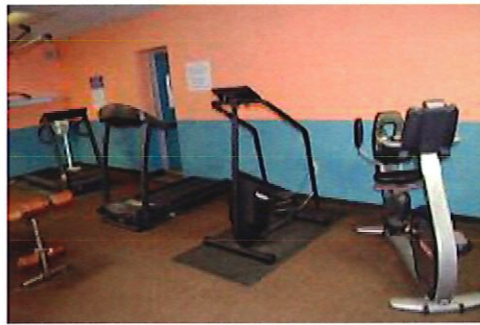
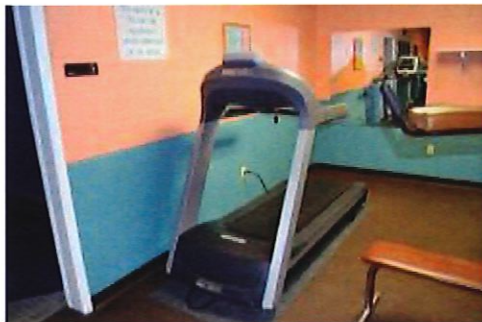
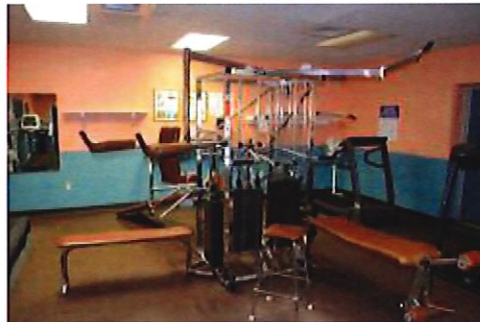
It is our market observation that while minor additions and/or replacements can be expected from time to time, better quality properties complete exercise equipment inventory replacements (treadmills, elliptical trainers, upright and recumbent exercise bikes, arc trainers, strength training stations, etc.) on a life cycle in the 10 year range, to insure the modern, appealing equipment is in use. This fund is designed to provide monies for as needed equipment replacements over a recurring 10 year life cycle. Based on the observed condition/age of the existing equipment and finishes, we would expect this expense in the near future. As there were no reported plans to make any significant exercise equipment/room upgrades in 2015, a summer 2016 expense date was forecast. The current lump sum cost estimate is an order of magnitude figure based on the size and quality of the existing inventory.

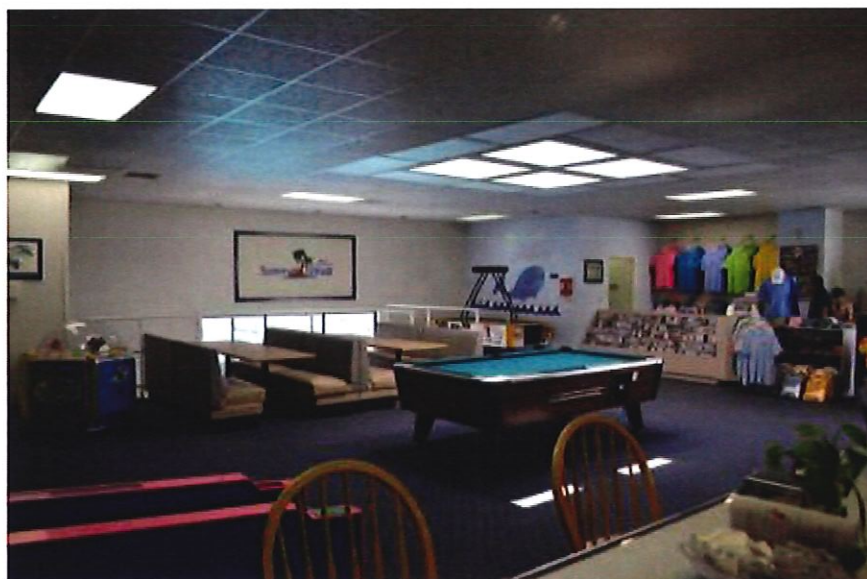
To insure a modern cosmetic appeal, the association should expect to complete major common area furnishings projects on a periodic and regular basis. While minor additions/replacements/upgrades can be expected from time to time, a life cycle in the 10 to low 10 year range is the market norm we have observed. This fund is designed to provide monies for as needed furnishings and finishes, including wall and ceiling finishes, booths/seating, bar stools, benches, wall art/mirrors, commercial fixtures, etc. in the sports complex over a recurring 10 year life cycle. A summer 2016 expense date was scheduled, accordingly. The pool table and video games are reportedly not association owned, and were excluded accordingly.

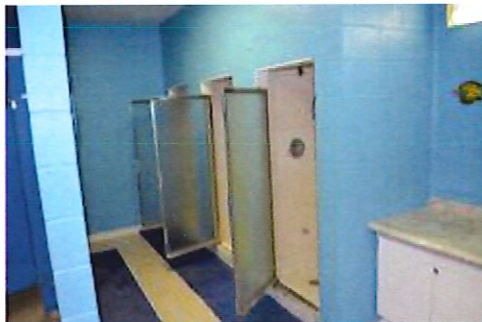
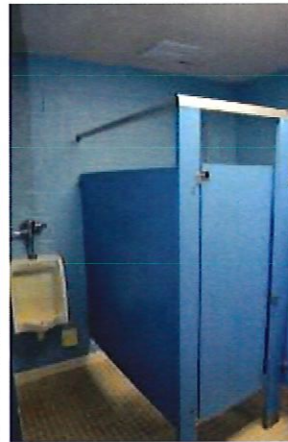
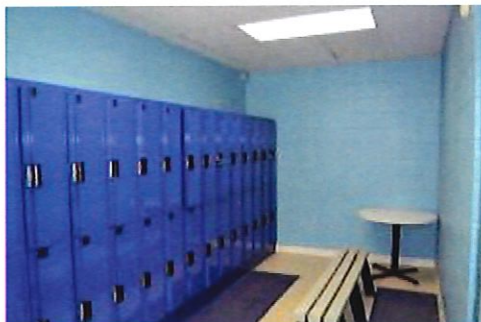
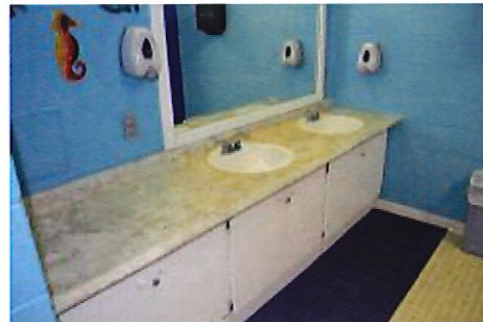
At some point in the foreseeable future, the association should expect to incur costs for major restoration of the common area restroom interiors (including, but not necessarily limited to, flooring, wall finishes, vanities, mirrors, dividers, plumbing and electrical fixtures, sauna interiors, etc.). Life cycles of less than 15 years, to 30+ years, have been observed in properties of similar quality. The existing finishes appear to be largely original to the property, and as there were no reported plans to complete renovations in 2015, a summer 2016 expense date was scheduled. The current cost estimate does not include any unforeseen floor area reconfiguration(s) and/or expansion(s).

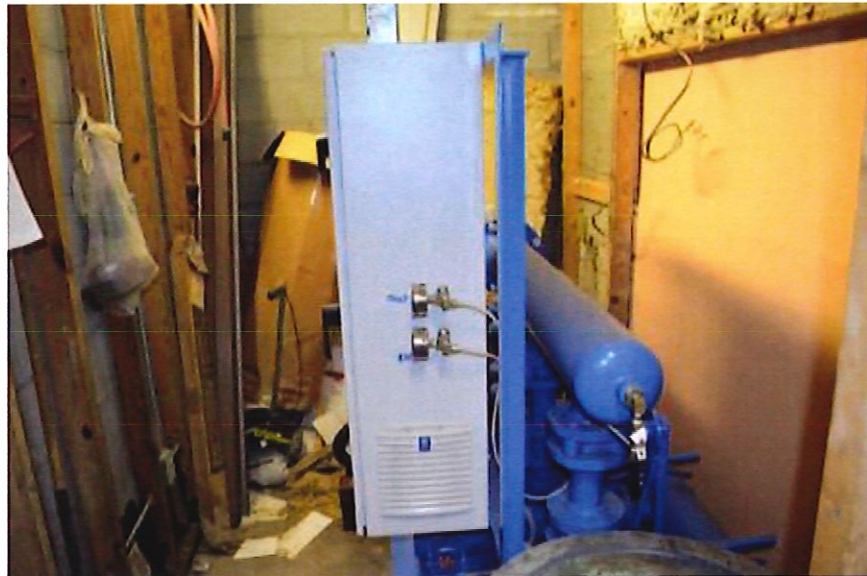
The common area mechanical equipment inventory includes a domestic water booster pump station/system, with three 5 hp pumps, controller panel, and associated equipment. Assuming periodic pump rebuilds, motor replacements, controller upgrades, etc. as a function of routine maintenance, modernization/replacement of standard domestic water pumps and equipment has a market indicated life cycle in the low to mid 20 year range.

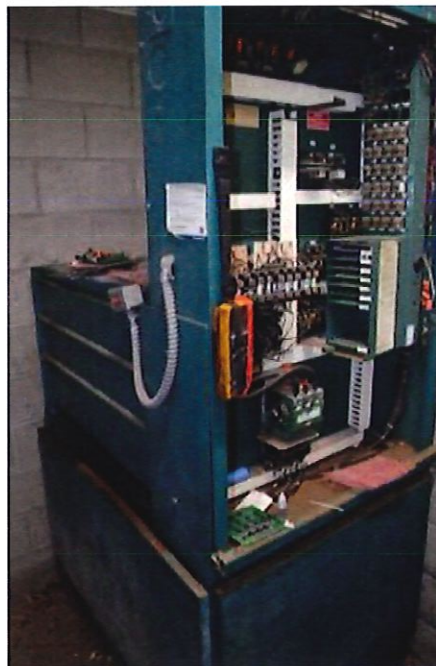
The useful life of the electrical and mechanical components (motors, controllers, door operators, call buttons, etc.) of hydraulic elevators can range rather widely. Typically, this upgrade is driven by an association's dissatisfaction with elevator speed, smoothness of ride, and/or noise. We have observed hydraulic elevator modernization after +/- 25 years, to over 40 years; our data set reflects a mid-range 30 year life cycle as being the most typical. The existing equipment is largely original to the property, reflecting an actual age of +/- 32 years. As such, this expense should be expected in the near future. This project will reportedly not be completed during the 2015 exterior restoration project, and a summer 2016 expense date scheduled accordingly.

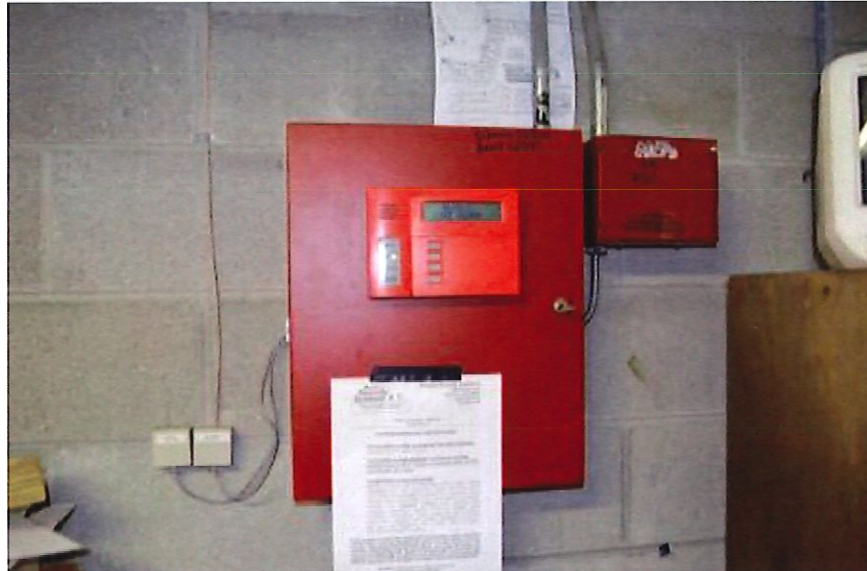
Given ever changing technologies and/or changing fire codes, we recommend that as these systems age, a qualified life safety engineer(s) assess the subject's fire alarm systems periodically to determine more specific remaining useful life and cost parameters. We reserve the right to modify this report upon receipt of such an assessment(s).

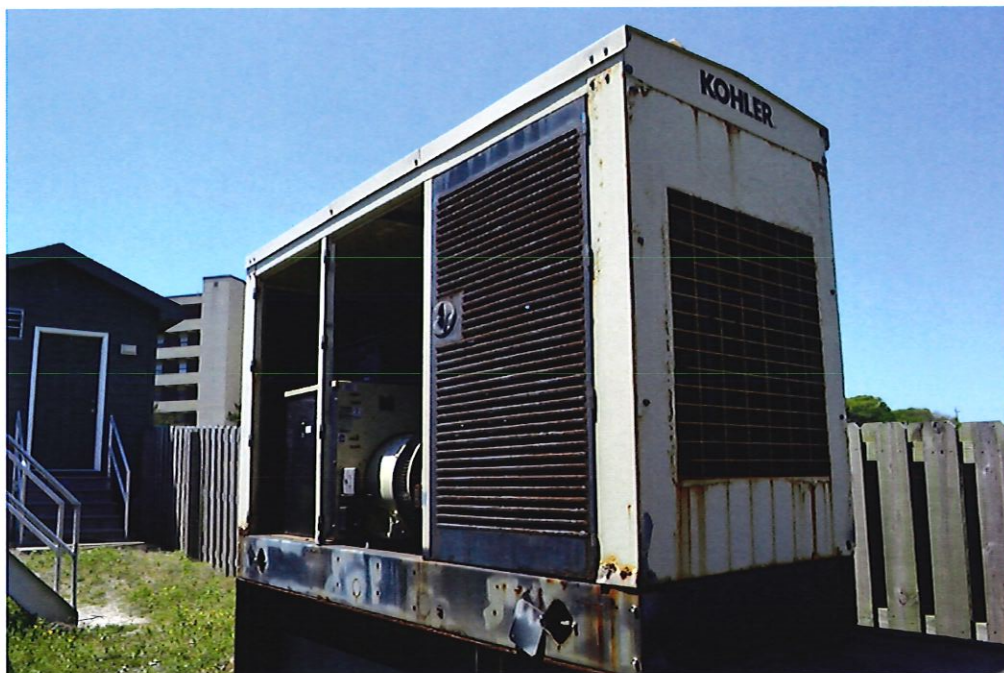
Life cycles in the low 20 year range have been observed for replacement of emergency generators located outside an enclosed building area, exposed to the corrosive ocean elements. This fund is designed to provide monies for as needed repairs to and eventual replacement of the 125 kW backup generator over a 21 year life cycle.

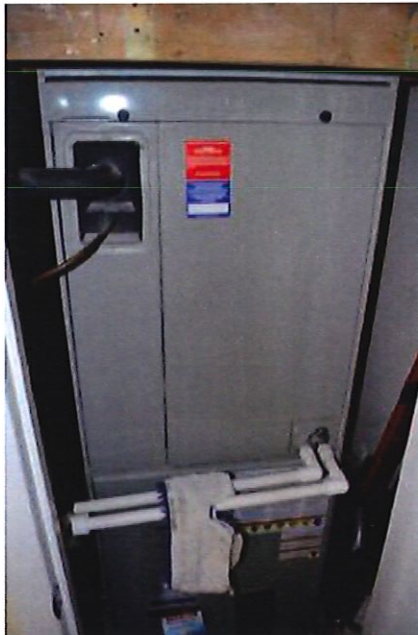
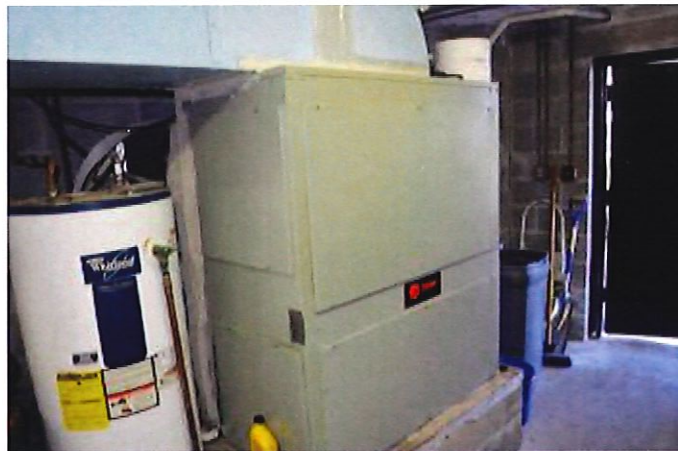
Life cycles in the mid-10 to low 20 year range have been observed for replacement of residential/commercial grade split HVAC air handler units in oceanside properties, assuming proper and routine maintenance. Changes to building codes have mandated that at the next replacement of an older, non-compliant condenser unit, the corresponding air handler must also be replaced so that both are brought up to more efficient, code compliant use. With the exception of the sports complex unit, which was assumed to be of the newer technology, the remaining useful lives were adjusted to reflect similar replacement dates as their matching condensers during the next replacement cycle; recurring 20 year life cycles were scheduled thereafter. The photographs are of representative air handlers.

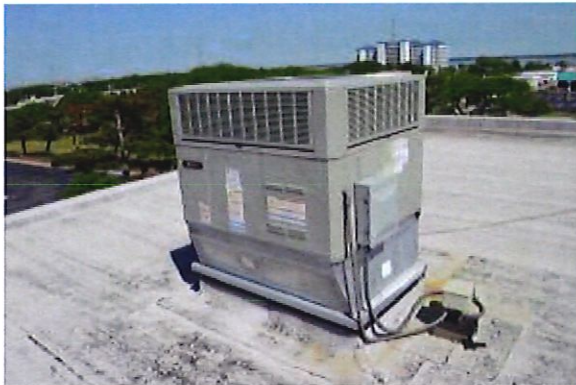
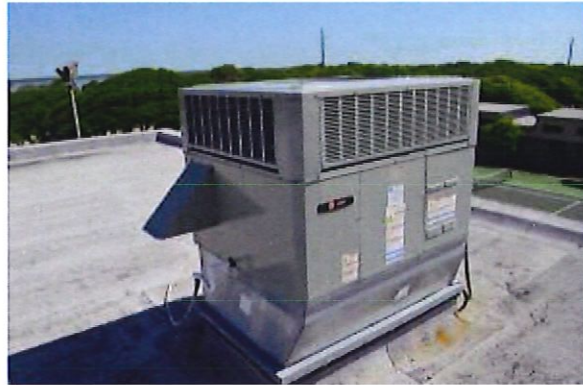
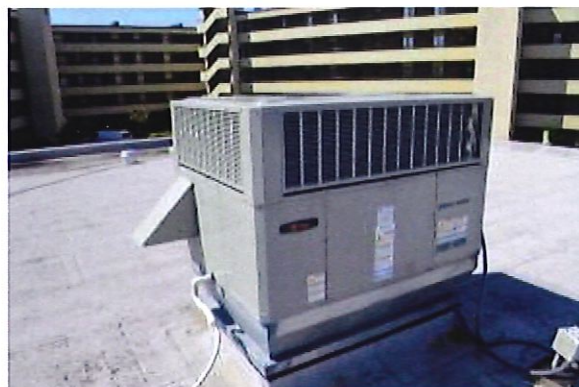
A life cycle in the low 10 year range should be expected for each of the three roof mounted package/RTU units supporting the sports complex interiors, which assumes proper and routine maintenance and installation of units designed for use in the corrosive ocean environment. Each was forecast for replacement again in 2025.

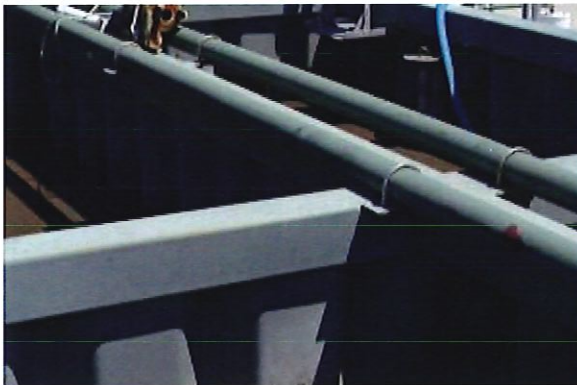
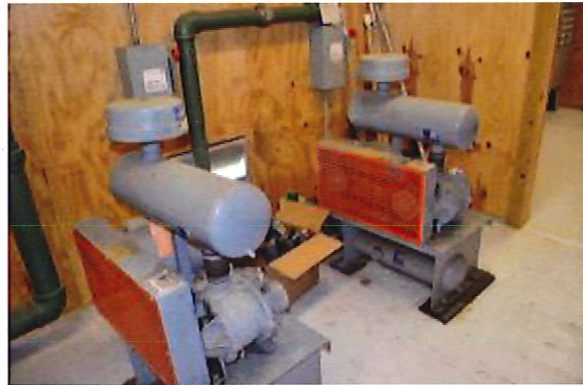
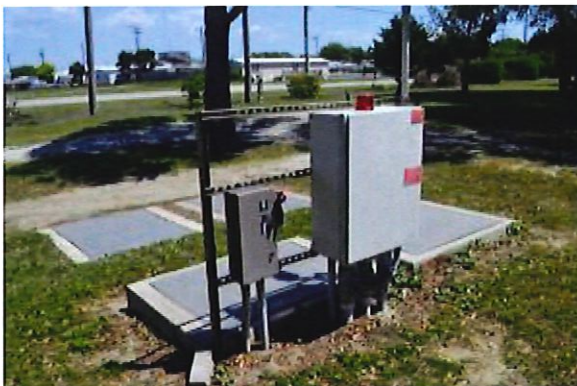
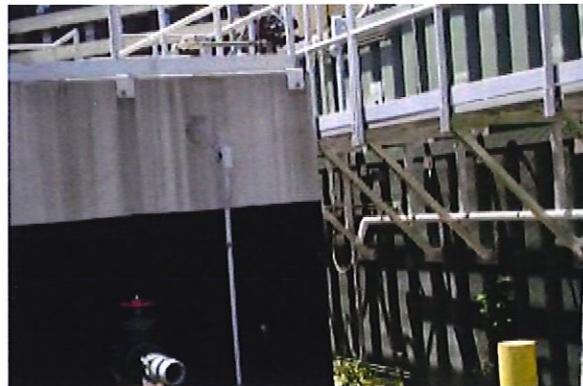
The association completed replacement of the original wastewater treatment plant in 2012, which reflects an actual useful life of +/- 29 years. This fund is designed to provide monies for as needed repairs to and eventual replacement over a 30 year life cycle, based on the actual operating history. The size in gallons per day was provided by the association, and assumed to be complete and correct.

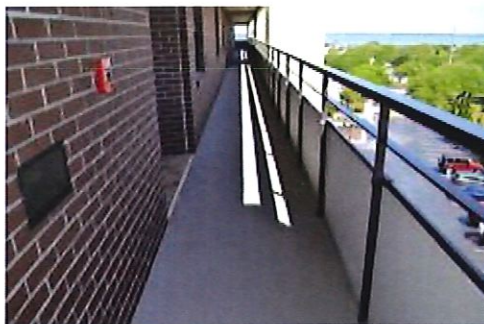
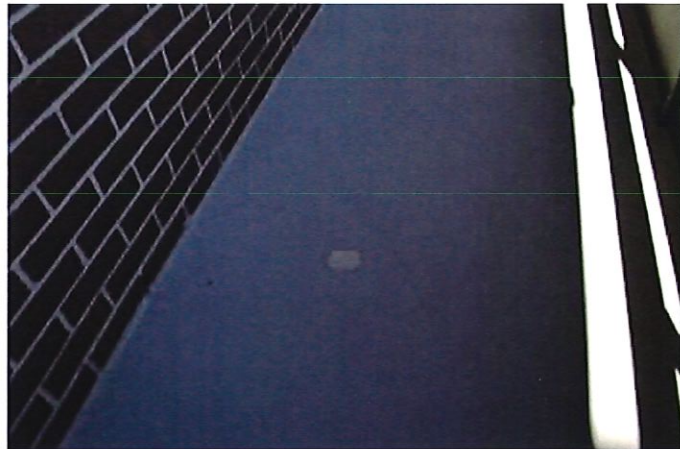
The 2015 exterior restoration project will reportedly include restoration/replacement of the waterproofing systems/traffic coatings on the common area corridors. The unit lanais are reportedly the financial responsibility of the owners and not the association, and as such, restoration/replacement of the waterproofing on the lanais was excluded from this report. It is our market observation that assuming proper installation and routine maintenance, life cycles in the low to mid 10 year range should be expected; we have observed other similar properties that complete this project at every other painting cycle, as a portion of a larger waterproofing project. This expense was scheduled again in 2029, and on a 14 year life cycle thereafter. The current cost estimate includes typical minor deck repairs.

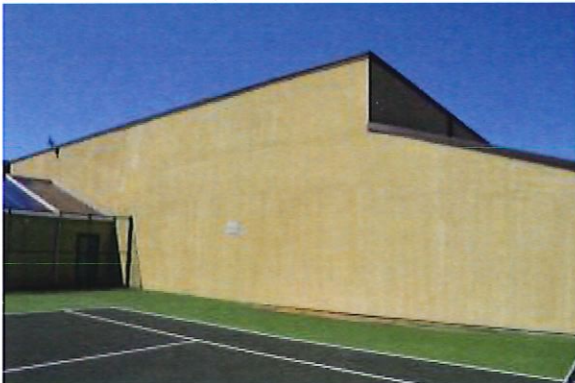
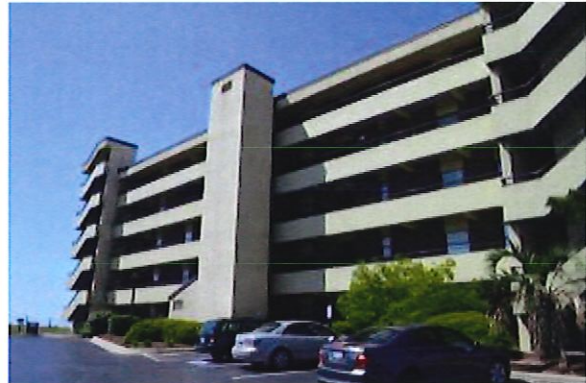
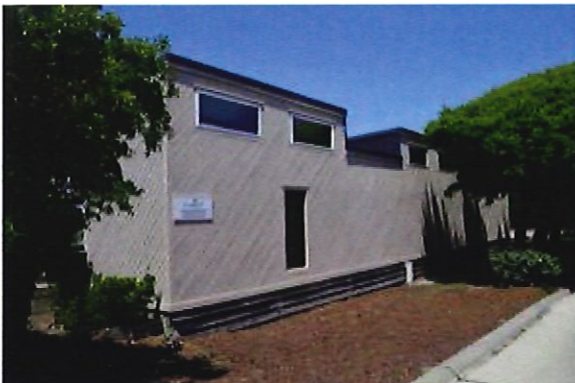
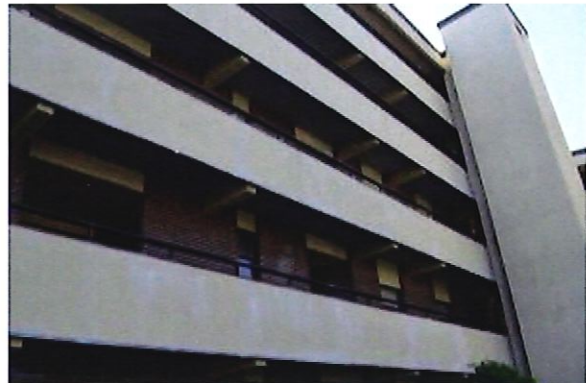
To insure proper protection of the underlying concrete, stucco, wood and metal surfaces, the market reflects a maximum 7 year useful life for exterior painting & waterproofing (in lieu of an association purchased 10 year warranty). This project will reportedly be completed in 2015 as a portion of the greater exterior restoration project, and a 2022 expense date scheduled accordingly. The current average per dwelling unit cost estimate includes typical minor concrete/stucco repairs, surface preparation, as needed window/sliding glass door caulking and painting/refinishing of all exterior concrete, stucco, wood and metal surfaces (including railings and window/slider frames).

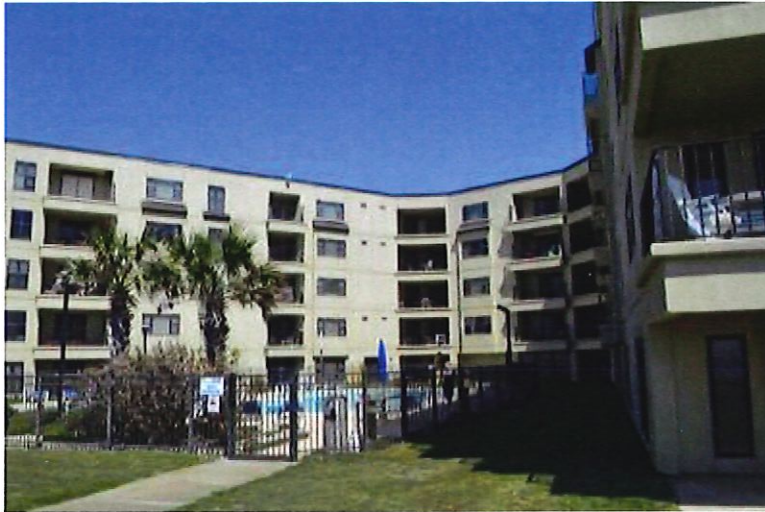
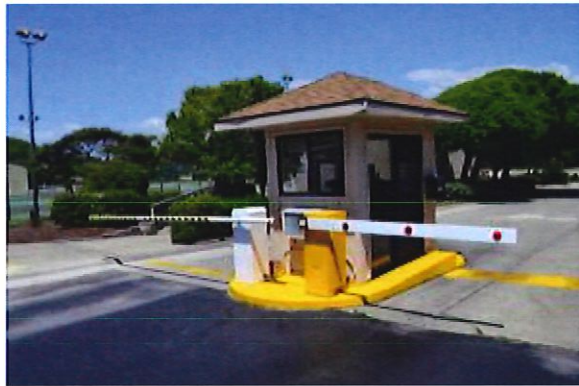
A determination of the condition of the exterior concrete systems is beyond the scope of this report. While it is certain that some measure of concrete restoration will be necessary in any property of the subject's design and construction with exposure to the ocean elements, it is very difficult to quantify budgetary costs and remaining useful lives. Costs can range from as low as \$5,000 per unit to over \$60,000 per unit, and useful lives can range from as low as roughly 15 years to over 40 years. It is our market observation that very few associations establish and fund major concrete restoration reserves, given the relative uncertainty of cost and useful life; it is much more common for these upgrades to be funded (at least partially) via special assessment. No reserves for concrete restoration were included in this report. Should the association wish to include reserves for concrete restoration, a budgetary funding goal and useful life cycle would need to be provided.

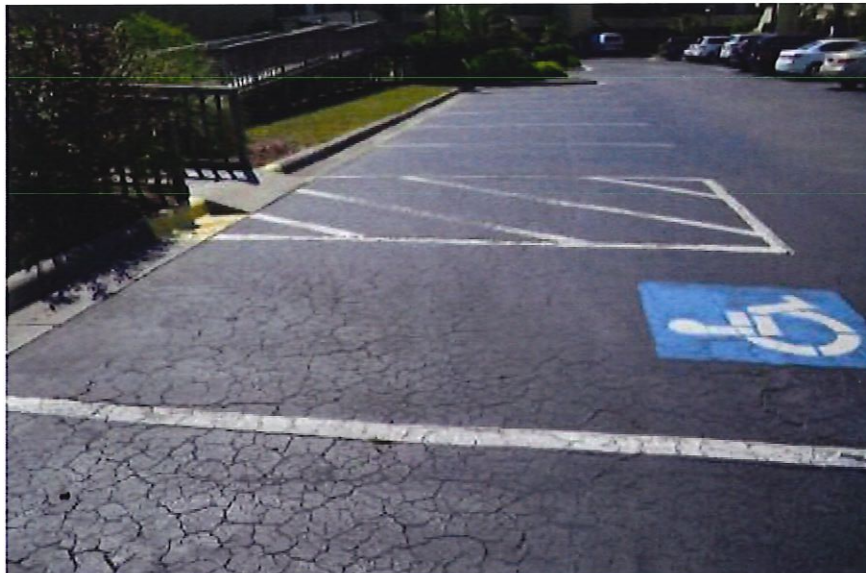
We have observed life cycles of less than 15 years, to 25+ years, for asphalt overlay projects, assuming proper design, installation and routine maintenance. The date of installation of the existing asphalt paving was not confirmed; it may indeed be original to the property. Areas of significant cracking/deterioration were noted, and it is our opinion that pavement replacement should be completed in the near future. Given the 2015 exterior restoration project, the remaining useful life was adjusted to reflect a summer/fall 2016 expense date. The current unit cost estimate includes milling/removal of the existing asphalt paving, typical minor repairs to the underlying pavement subbase and drainage systems, installation of new asphalt paving, and re-striping. The paved area is a rounded estimate.

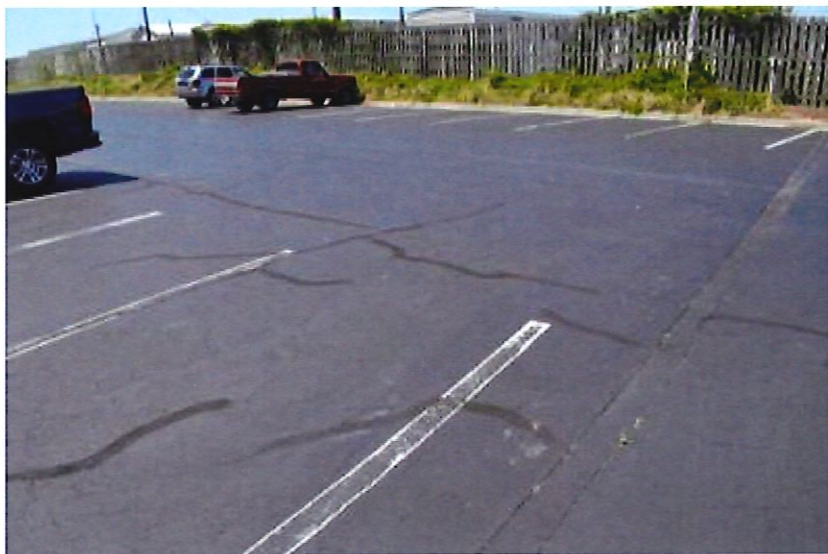
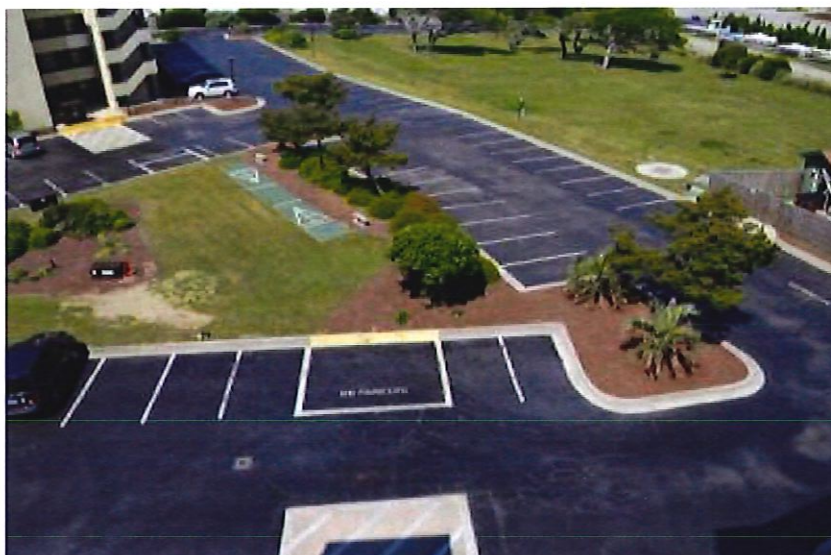
Under normal conditions, total replacement of concrete paving (sidewalks, curbing, gutters, etc.) should not be necessary at any one given time. It is our market observation that while some associations do establish and fund contingency reserves for concrete paving repairs, many prefer to fund as needed repairs through their annual operating budgets, as a function of routine maintenance. No reserves for concrete paving were included in this report.

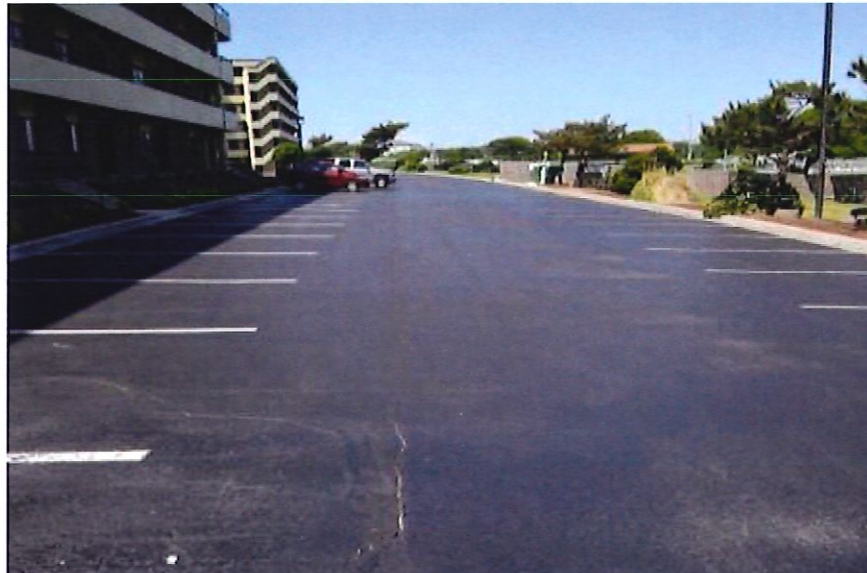
Sealcoating/rejuvenation of asphalt paving serves as not only a cosmetic upgrade; it also insures minimal moisture intrusion into the underlying pavement structure. Without a proper moisture barrier, premature deterioration in the form of potholes, etc. can occur, causing the need for more frequent (and costly) asphalt overlays. The market reflects a typical useful life of 3-4 years for this upgrade. Assuming a pavement replacement project in 2016, and based on observed industry standards that indicate that a sealcoating project should be completed within the first year of a new pavement installation project, this expense was scheduled in summer 2017. A recurring 4 year life cycle was scheduled thereafter. The current cost estimate includes typical minor pavement repairs and re-striping.

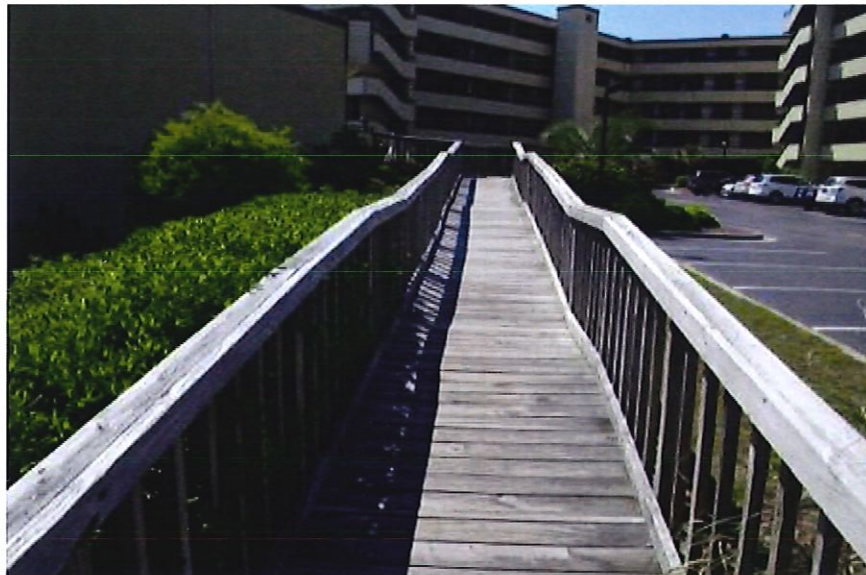
Assuming proper and routine maintenance, including as needed board replacements, sealing, etc., third party restoration of the wood frame/deck ADA ramp at the sports complex (replacement of wood decking and railings, as needed repairs to underlying framing, stringers, pilings, etc.) should be expected on a life cycle in the 10-11 year range. Based on the observed condition, we estimate an effective age in the 10 year range and forecast this expense in 2017. The current cost estimate is not reflective of total replacement; under normal conditions, we do not anticipate the need for total replacement in the foreseeable future.

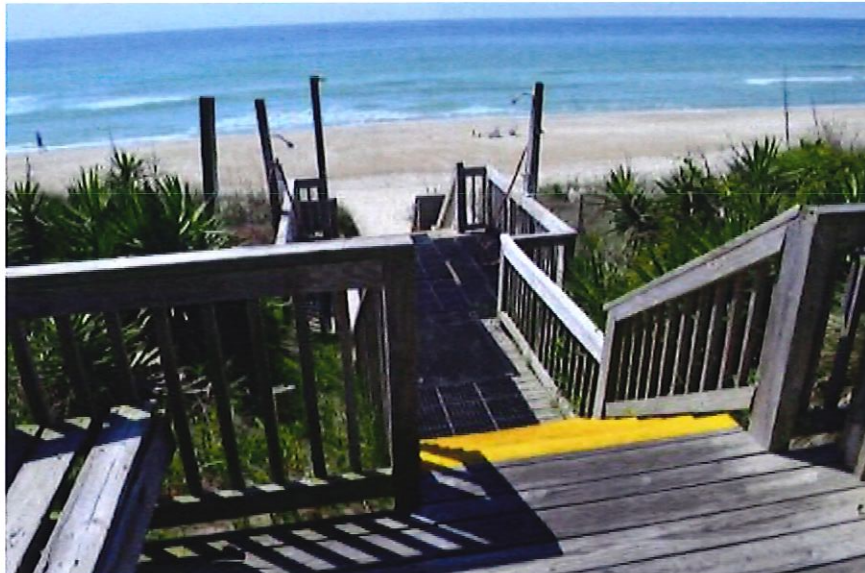
Assuming proper and routine maintenance, including as needed board replacements, sealing, etc., third party restoration of the wood frame/deck dune crossovers (replacement of wood decking and railings, as needed repairs to underlying framing, stringers, pilings, etc.) should be expected on a life cycle in the 10-11 year range. Each was forecast for restoration on a recurring 11 year life cycle, accordingly, with summer 2016 expense dates. The current cost estimate is not reflective of total replacement; under normal conditions, we do not anticipate the need for total replacement in the foreseeable future.

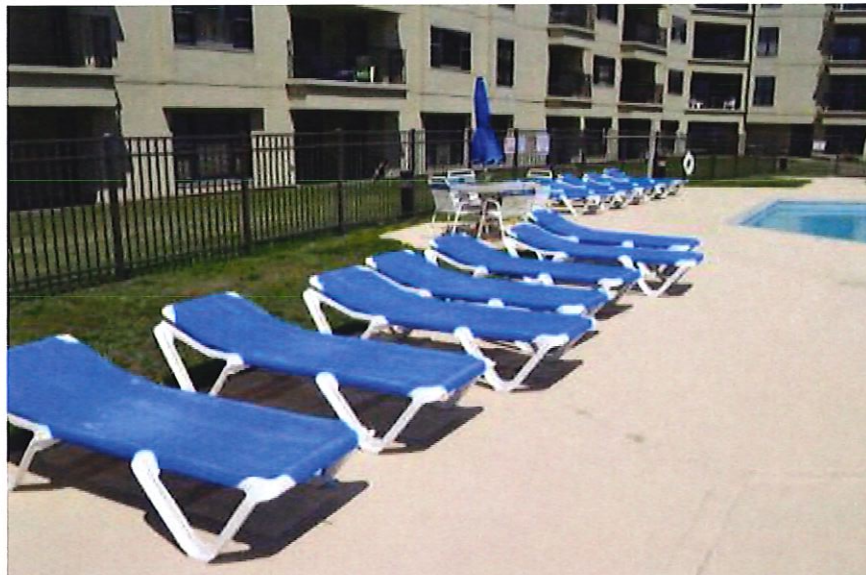
While minor additions/replacements can be expected from time to time, and assuming periodic as needed re-strapping and/or refinishing as a function of routine maintenance, most associations complete pool deck furniture inventory replacements on a 7-10 year life cycle. This fund is designed to provide monies for as needed pool deck furniture replacements over a recurring 10 year life cycle. The current per piece cost estimate is an average figure for the differing types (i.e. chaise lounges, tables, chairs, umbrellas, trash receptacles, etc.).

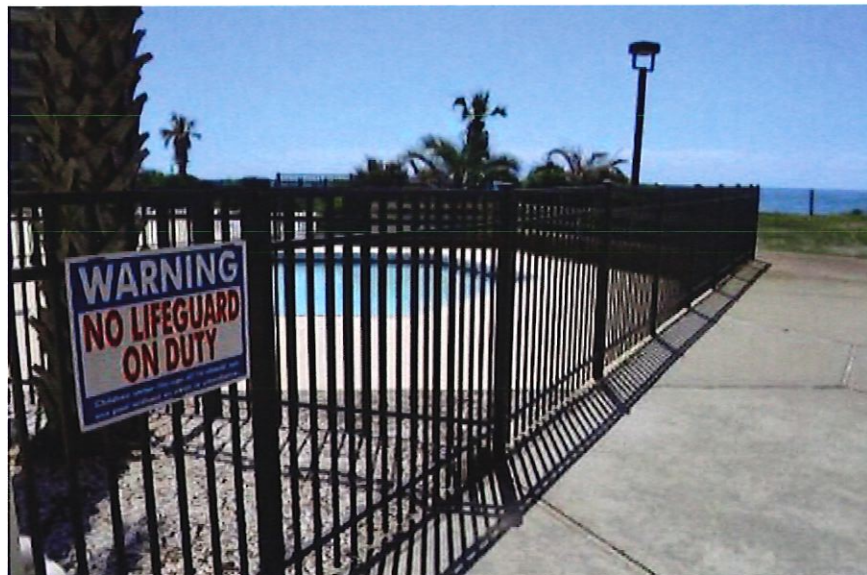
A life cycle in the low to mid 20 year range is the most typical useful life we have observed for replacement of standard aluminum pool/spa deck fencing and gates. Separate line items were included to provide monies for as needed repairs to and eventual replacement of the pool fencing/gates at each pool area, over 24 year life cycles. The current per linear foot cost estimate includes removal and disposal of the existing fencing and gates and installation of like height/quality fencing and gates.

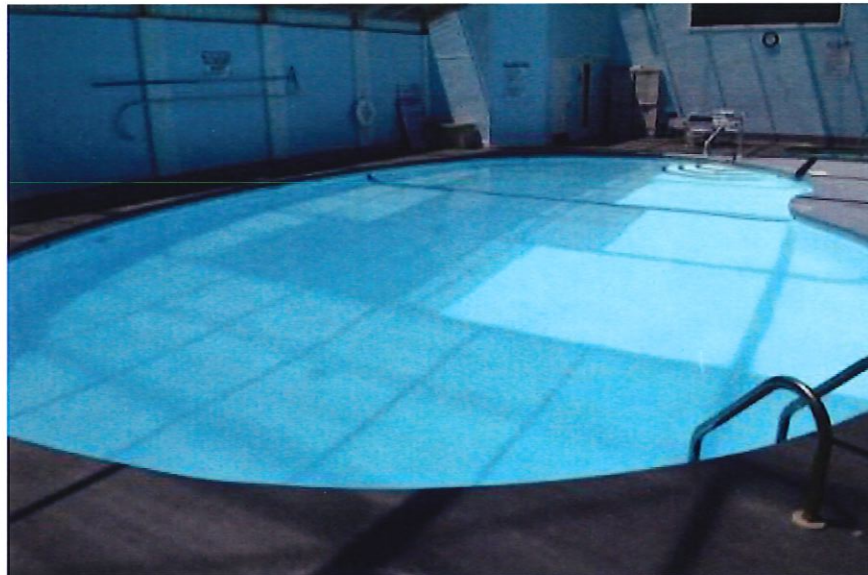
Given the lesser exposure to the sun, interior resurfacing/restoration of the natatorium swimming pool should be expected on a slightly longer life cycle than the outdoor pools. A 14 year life cycle estimate reflects a 2027 expense date for this project, based on the reported spring 2015 completion date. The current cost estimate includes typical minor tank/structural repairs, tile upgrades and/or replacements, and installation of new aggregate surface materials (i.e. "diamond brite", "pebble crete", etc.), and is based on the approximate surface area of this free form pool.

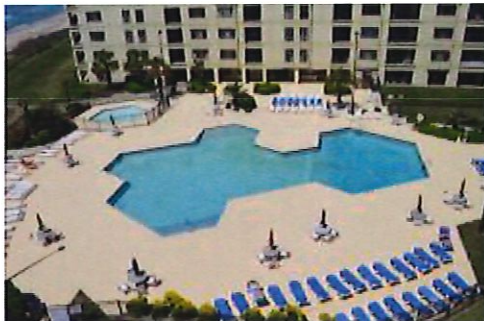
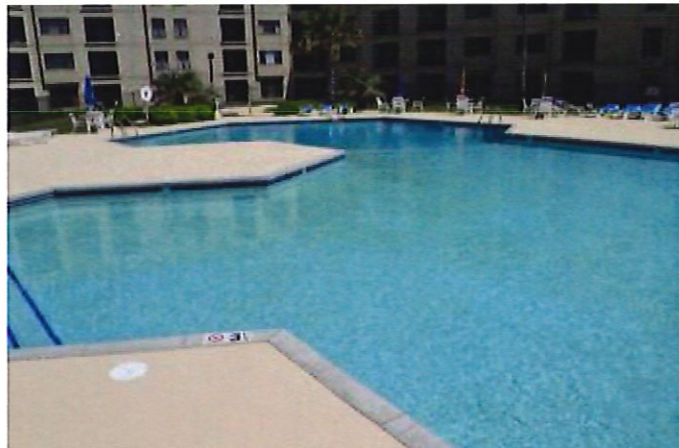
Assuming proper installation, chemical balancing, and routine maintenance, interior resurfacing of standard concrete pools with marcite or aggregate interior finishes should be expected on a life cycle in the 10-12 year range. The current per square foot of surface area cost estimate includes typical minor tank/structural repairs, tile upgrades and/or replacements, and installation of new aggregate surface materials (i.e. "diamond brite", "pebble crete", etc.). The pool surface areas are rounded estimates.

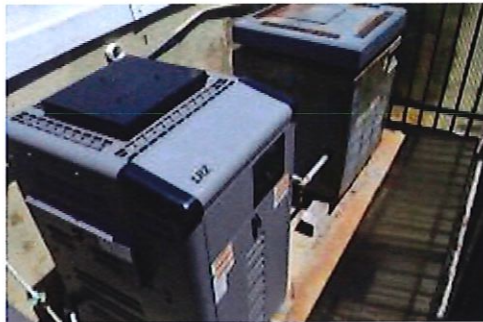
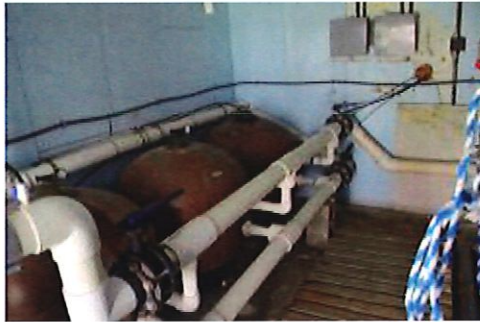
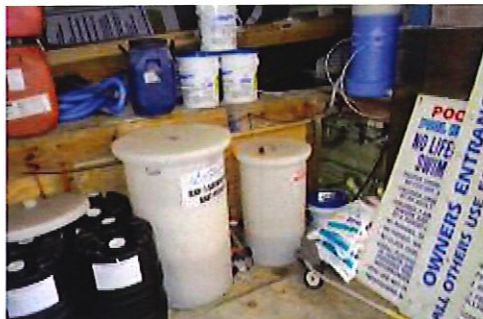
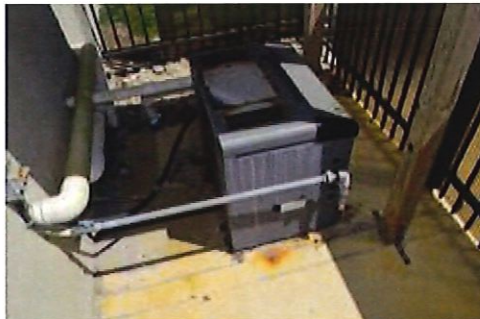
Under normal conditions, total replacement of pool and spa equipment inventories (pumps, motors, chlorination systems, filters, heaters, etc.) should not be necessary at any one given time. As such, reserving for total replacement is not considered prudent or practical. This is supported by our review of reserve budgets at similar properties; while some associations establish and fund contingency reserves for as needed repair/replacement costs, others prefer to fund incidental expenses through their annual operating budgets, as a function of routine maintenance. For the association's consideration, we have included an allowance to provide monies for as needed equipment replacements over a recurring 10 year life cycle. This fund is a projection only; actual costs and time frames may vary from these estimates. The current cost estimate is not reflective of total inventory replacement.
