**A RESERVE STUDY UPDATE FOR**

**Summer Winds  
Condominiums, Inc.  
Indian Beach, North Carolina  
File #22920-00929**

**FOR PERIOD: October 1, 2015 – September 30, 2016**

**PREPARED BY  
GAB ROBINS, A DIVISION OF CUNNINGHAM LINDSEY  
3300 W. LAKE MARY BLVD.  
SUITE 350  
LAKE MARY, FLORIDA 32746-3405  
(800) 248-3376 ext. 257  
(407) 805-0086 ext. 257**

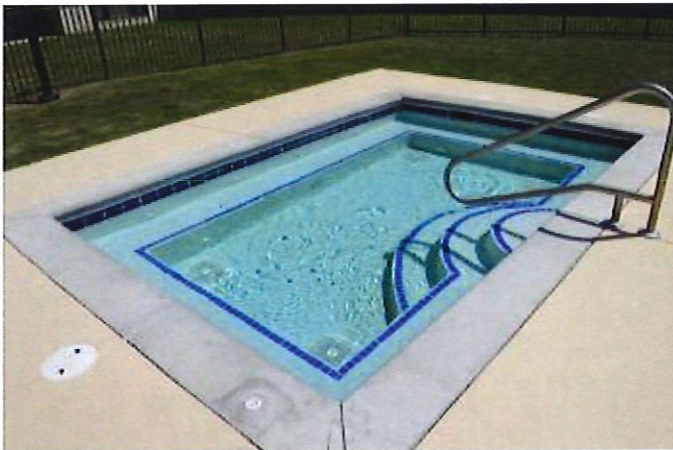
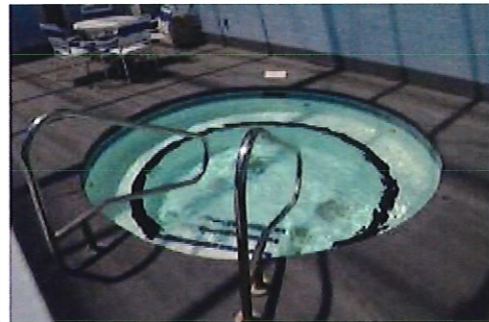
Given the higher temperatures and chemical concentrations, interior resurfacing of standard concrete spas with marcite or aggregate interiors is typically necessary on a shorter life cycle than similar pool interiors. Life cycles in the 7-10 year range have most typically been observed, assuming proper installation, chemical balancing and routine maintenance. Recurring 8 year life cycles were forecast for the Building A and natatorium spa interiors, accordingly.

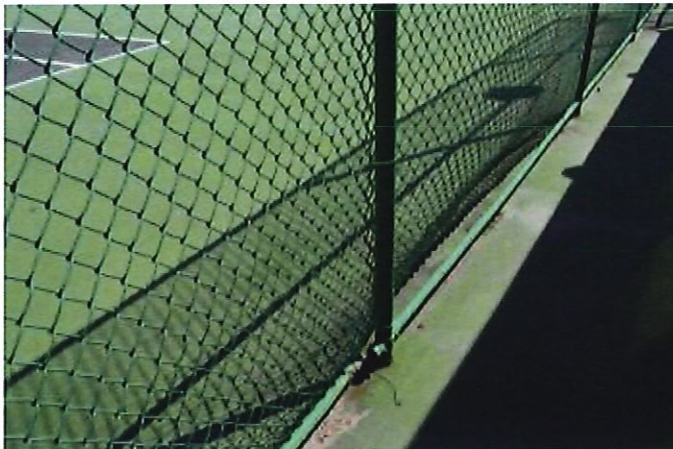
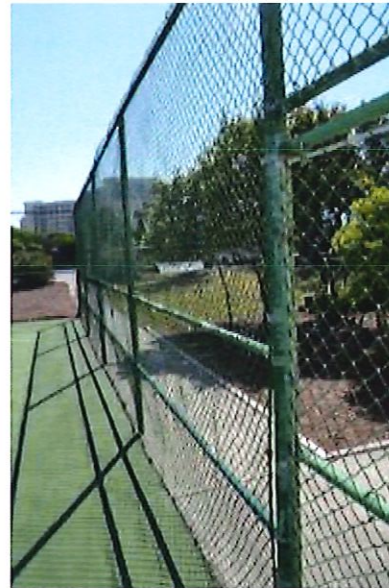
Data gleaned from both within and outside the local market area indicates that under normal conditions, replacement of typical coated chain link tennis court fencing and gates should be expected on a life cycle in the low to mid-20 year range. The existing fencing/gates were observed to be in only fair condition, and may be original to the property; replacement will reportedly be completed prior to October 1, 2015, and a 2038 replacement date scheduled accordingly. The current per linear foot unit cost estimate includes removal and disposal of the existing fencing and gates and installation of like height/quality fencing and gates.

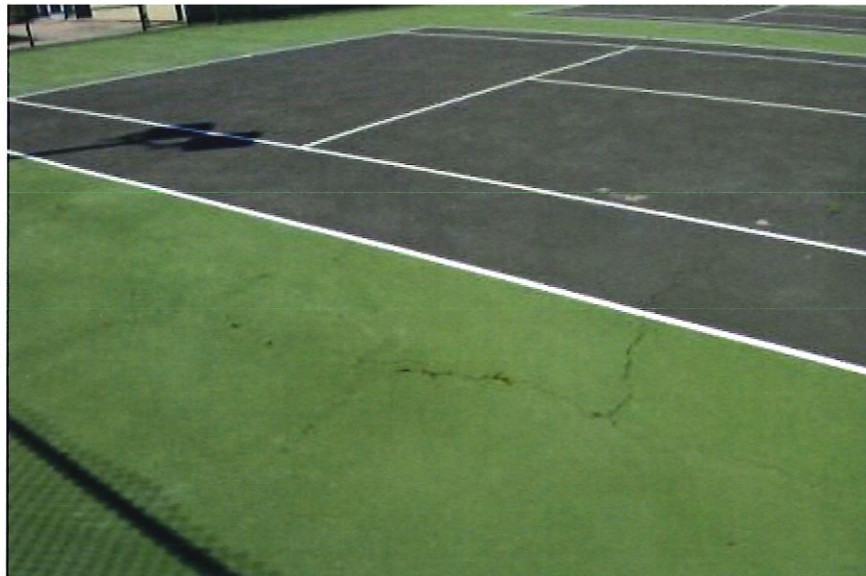
To insure proper protection of the underlying court structures and a high cosmetic appeal, the market reflects a range in useful life of 6-9 years for resurfacing of standard asphalt tennis courts. The tennis court surfaces were observed to be in fair to poor condition, with significant areas of cracking/deterioration noted. In our opinion, this project should be completed in the near future. The current per court cost estimate includes typical minor repairs to the underlying court structures and re-stripping.

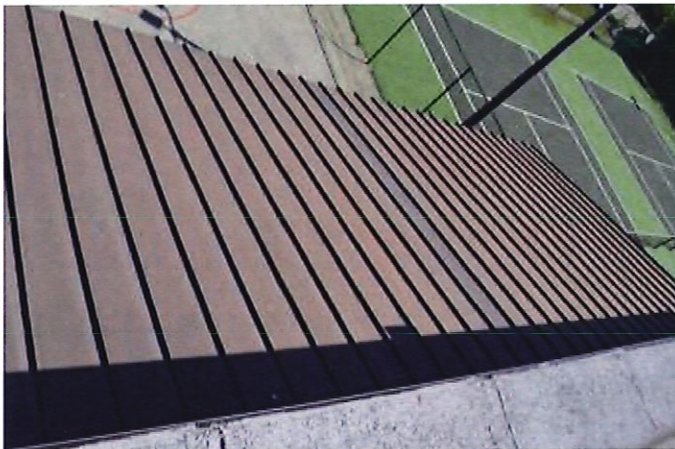
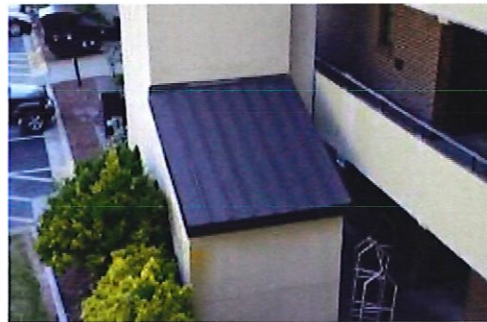
The pitched metal roofing at the sports complex and residential buildings appear to be original, suggesting actual ages of +/- 32 years. It is our market observation that this type of roofing should have a useful life in the 25-30 year range, which indicates that replacement should be expected in the near future. This expense was forecast in 2016, accordingly. The total square footage is a rounded estimate.

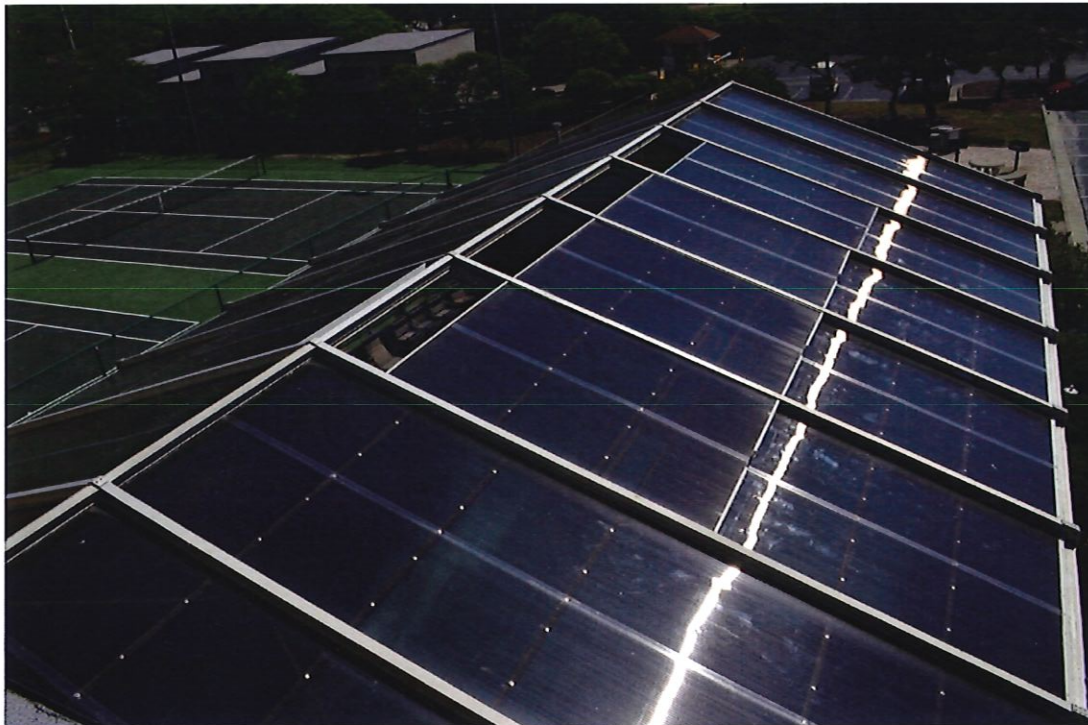
The association completed replacement of the movable skylight panels and motors in early 2015, at a reported cost of +/- \$52,000. This fund is designed to provide monies for as needed repairs to and eventual replacement of these components over a 30 year life cycle.

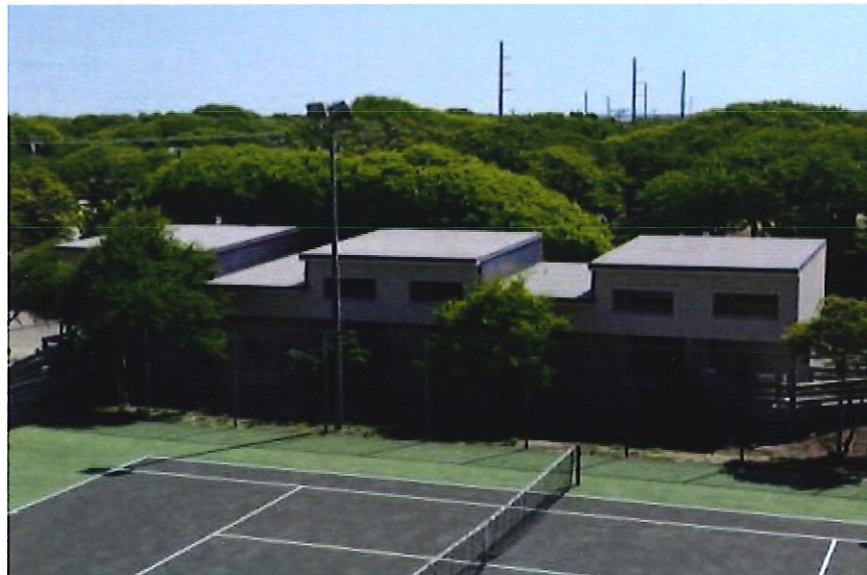
Data gleaned from both within and outside the local market area reflects a probable life cycle in the 18-20 year range for a properly designed, installed and maintained flat/membrane roof. Based on its reported 2006 installation date, and as no professional roofing studies were provided that would suggest that physical conditions exist at this (or any other common area) roofing, a 2026 replacement date was scheduled. The current cost estimate includes removal and disposal of the existing roofing, typical minor repairs to the underlying roof structures, flashing, etc. and installation of like roofing.

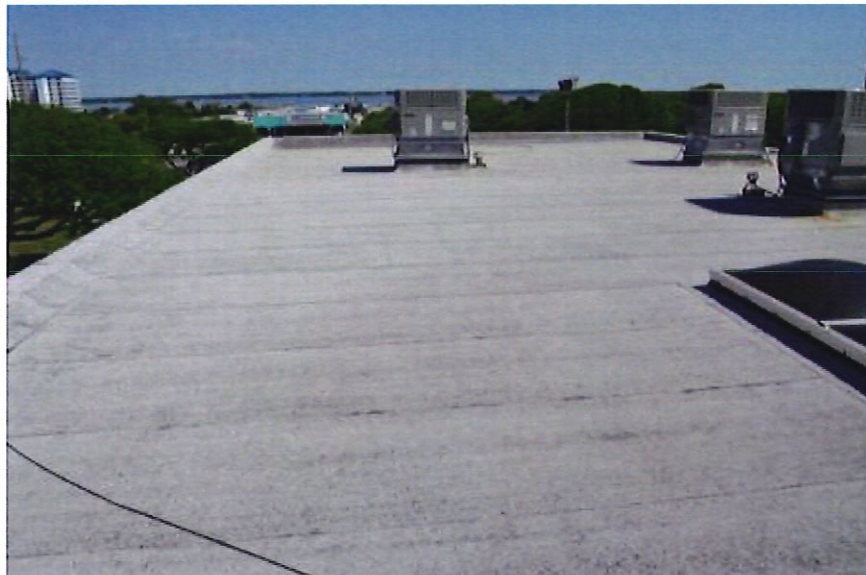
Data gleaned from both within and outside the local market area reflects a probable life cycle in the 18-20 year range for a properly designed, installed and maintained flat/membrane roof. Based on its reported 2006 installation date, the sports complex flat roofing was forecast for replacement in 2026. The current cost estimate includes removal and disposal of the existing roofing, typical minor repairs to the underlying roof structures, flashing, etc. and installation of like roofing.

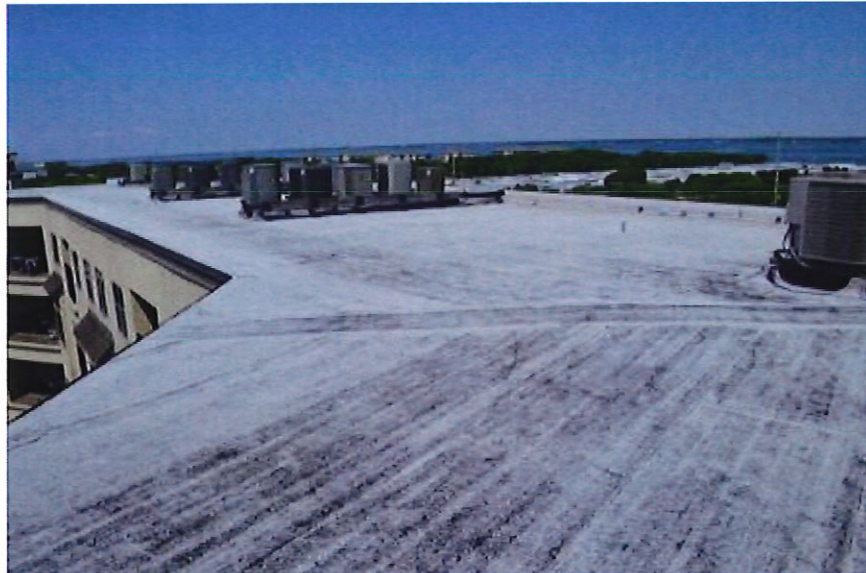
Data gleaned from both within and outside the local market area reflects a probable life cycle in the 18-20 year range for a properly designed, installed and maintained flat/membrane roof. A 20 year life cycle estimate reflects a 2026 replacement date for the residential tower buildings' flat roofs. The current cost estimate includes removal and disposal of the existing roofing, typical minor repairs to the underlying roof structures, flashing, etc. and installation of like roofing.

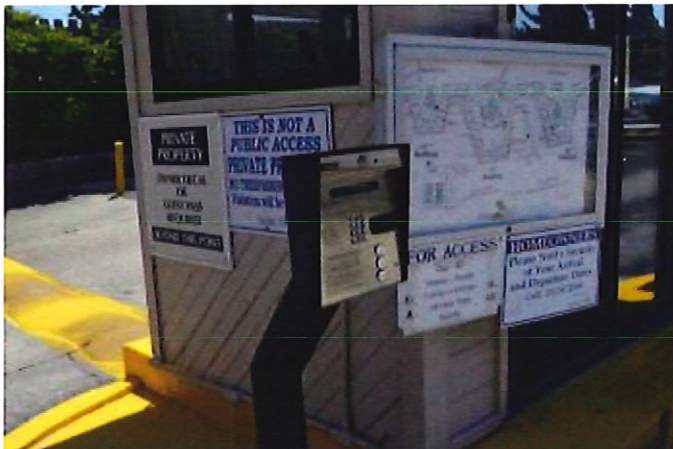
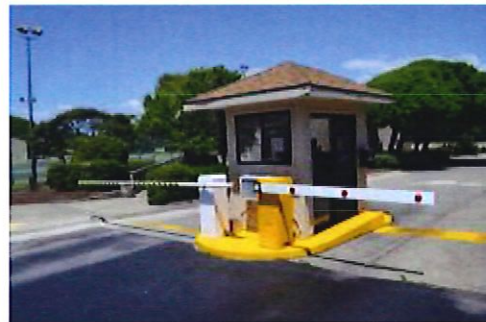
Barring any unforeseen vehicular damages, a life cycle in the low to mid 10 year range is the observed market norm for modernization/replacement of security access control systems/equipment/gates. This fund is designed to provide monies for as needed repairs to, and eventual modernization/replacement, of this equipment over a recurring 12 year life cycle, based on the reported fiscal year 2014/2015 installation date.

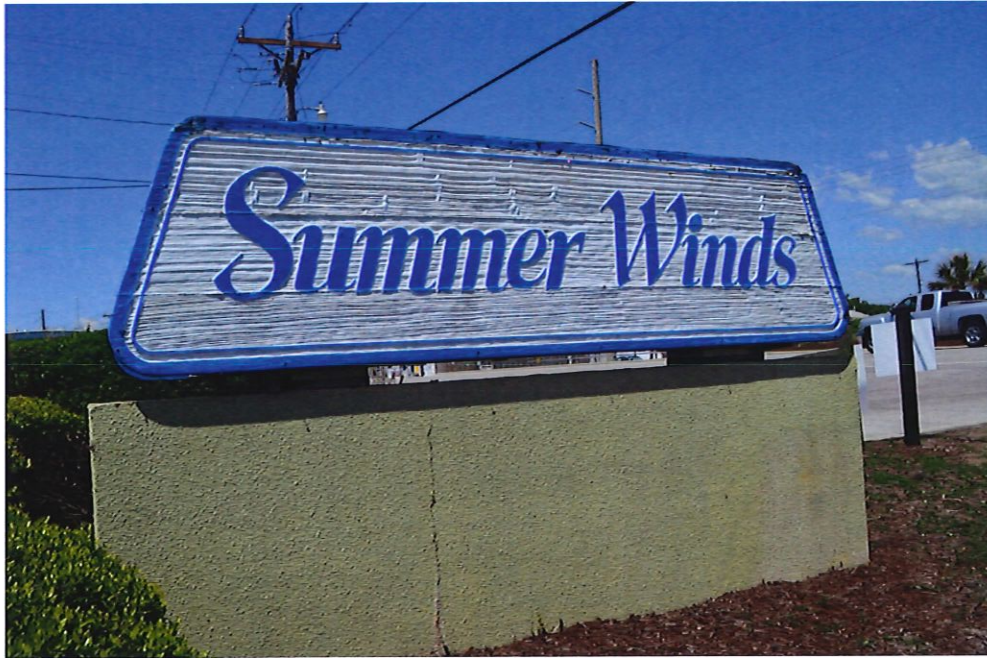
This line item refers to costs associated with major restoration and/or replacement of the two entry marquees. The placed in service dates of this signage was unknown; based on the observed condition, we do not anticipate any major expenditures in the near future, and a 2020 expense date forecast. The actual costs may vary due to association cosmetic tastes.

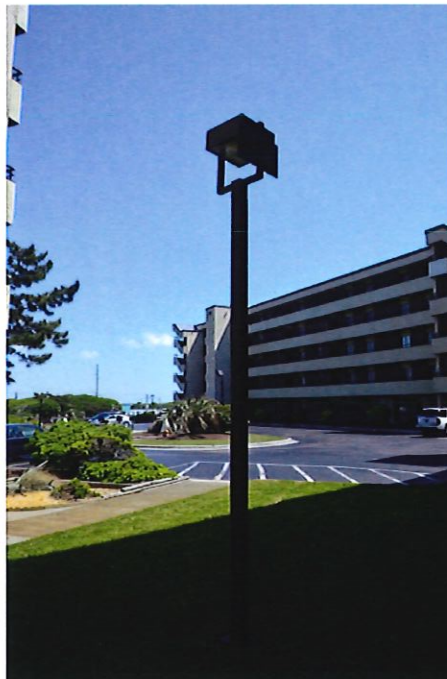
While minor replacements will be necessary on as needed, incidental basis, total inventory replacement of on-site poles/light fixtures is typically necessary on a 25-30 year life cycle. The existing inventory appears to be largely original to the property, suggests a major expense in the near future. This expense was forecast in 2016, to be completed with the scheduled asphalt paving and tennis court projects. The current cost estimate is based on the total of 35 poles/fixtures (tennis/sports courts, parking areas, pool decks) and an average per unit cost of \$1,855. It was assumed that replacement of the smaller pedestal, on building and landscaping lighting would continue to be funded through the association's annual operating budget, as a function of routine maintenance.

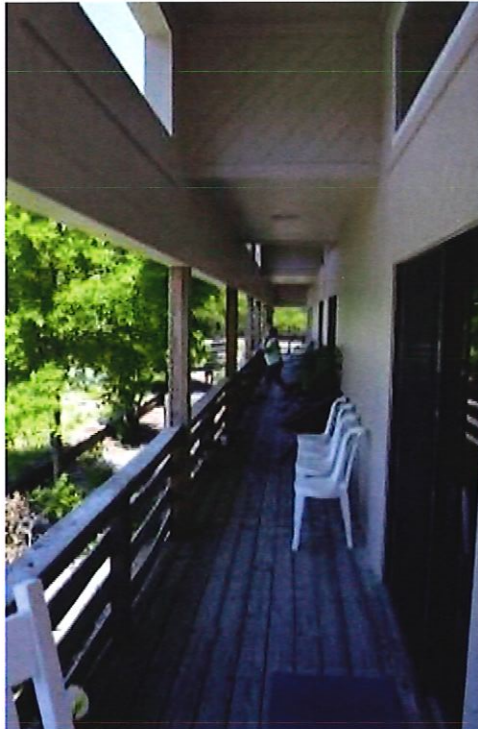
Given the more limited exposure to the sun, third party restoration of the wood frame/deck (replacement of wood decking and railings, as needed repairs to underlying framing, stringers, pilings, etc.) at the office building decks should be expected on a longer life cycle than the dune crossovers or ADA ramp. This decking is reportedly original to the property, suggesting an actual age of +/- 32 years. This is well beyond the typical useful life we have observed before major restoration is necessary. Based on its observed condition, we estimate that this project will be necessary in the next 3-5 years, and a 2019 expense date forecast accordingly. The current cost estimate is not reflective of total replacement; under normal conditions, we do not anticipate the need for total replacement in the foreseeable future.

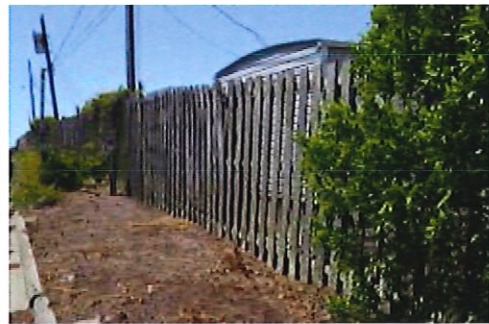
Barring any unforeseen storm damages, etc., replacement of the shadowbox privacy fencing along the east and west property boundaries should be expected on a life cycle in the mid-10 year range. The most recent major expense was incurred in 2006, per prior discussions with the property manager, and a 2022 replacement date scheduled accordingly. The current cost estimate is an order of magnitude figure based on the approximate linear footage, and is reflective of third party replacement.
